**2016 CIGRE-IEC Colloquium**  
May 9-11, 2016  
Montréal, QC, Canada

## **Testing of 400 kV GIS**

**ROBERT LE ROUX, DERMOT DORGAN, BRIAN PERRY**  
**ESB International**  
**Ireland**

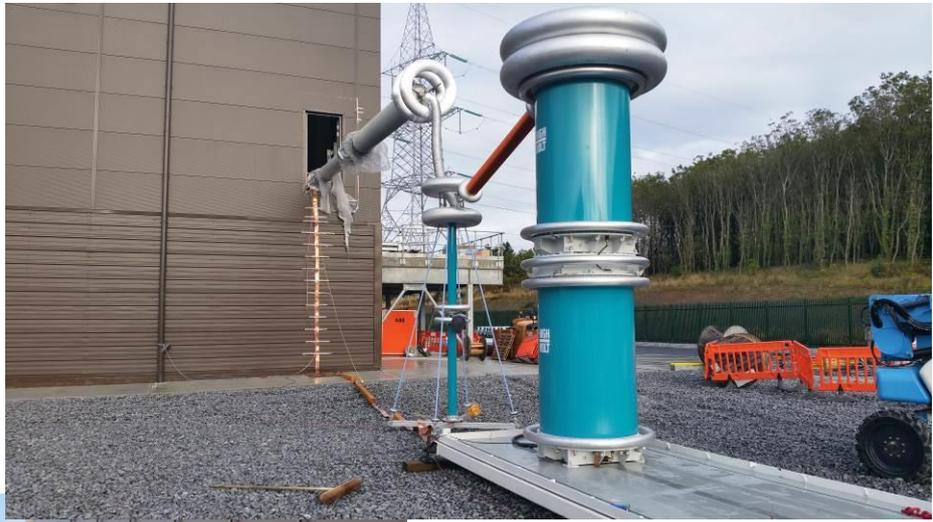
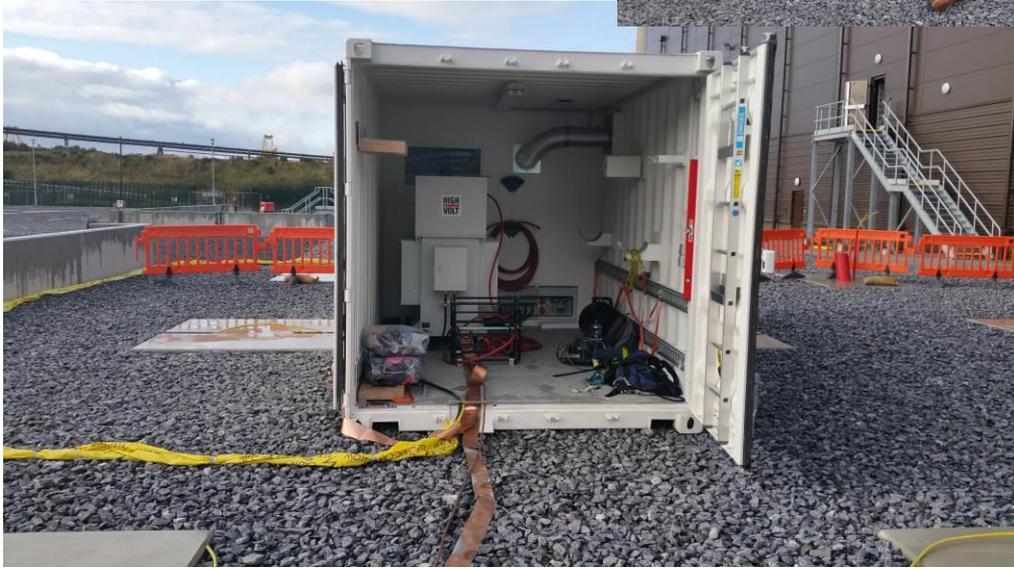
**Right and below – HV Resonance test set used for site testing.**

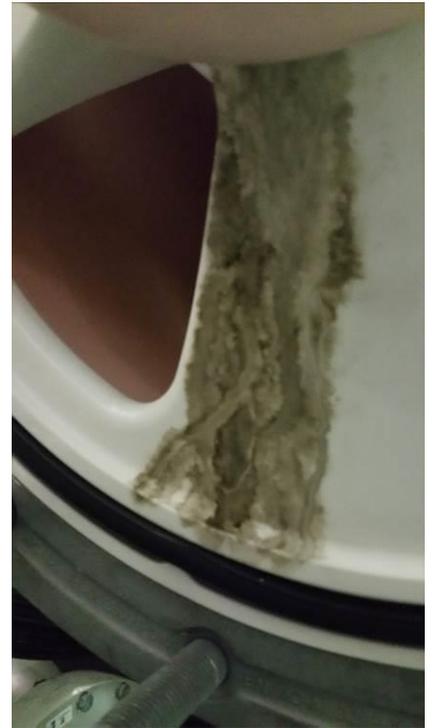
**Right – failure on insulator during site High Voltage test**

During the site testing there were fourteen occurrences of flashover or partial discharge. The reason for almost all the occurrences were due to metallic particles inside the gas compartments or due to voids within the insulators.

After replacement and cleaning of the affected sections / chambers, the tests were repeated and then passed the required IEC clause of the HV tests.
