2016 CIGRE-IEC Colloquium
May 9-11, 2016
Montréal, QC, Canada

LIFE EXTENSION TECHNIQUE FOR EXTRA HIGH VOLTAGE POWER CABLES

H C Sharma, D R Dharmadhikari, Kapil Kumar
Tata Power Delhi Distribution Limited (TPDDL)
INDIA

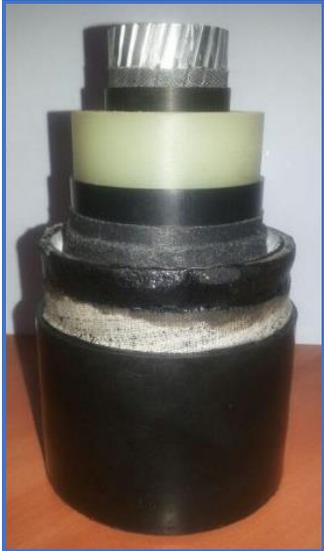
In single core cables, due to induction effect, voltage gets generated in the cable sheath as per right hand grip rule. The sheath acts a secondary of the transformer while conductor acts as primary.

Fig-1, Single core cable.

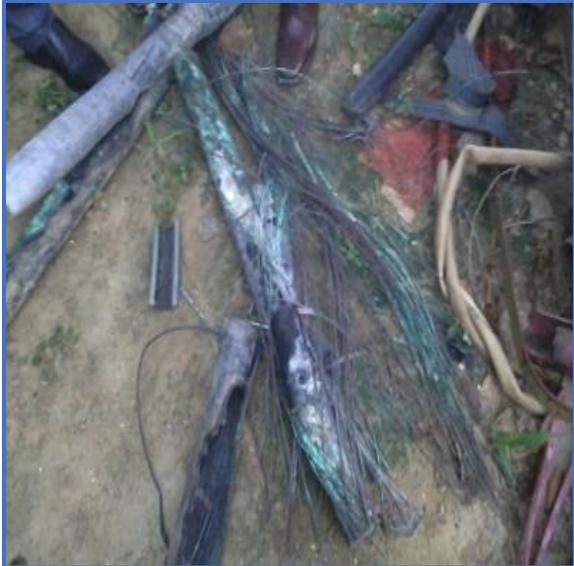
- 1) The damage to link box by agencies working or water ingress in the link boxes.
- 2) The damage to the outer sheath of the cable in between.

Fig-7, Damaged Cable

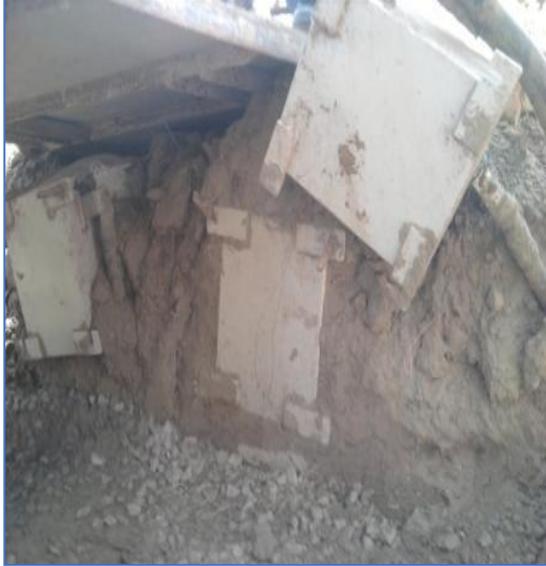
Fig-8, Damaged Link box

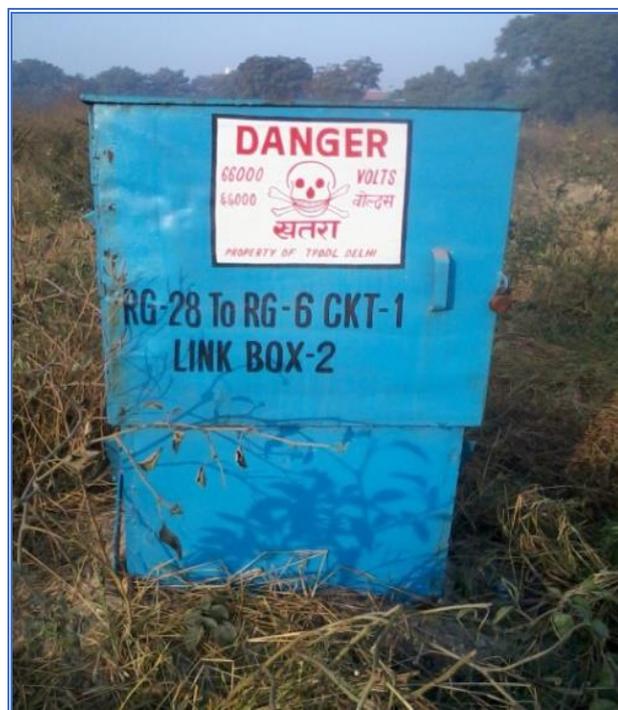
To practically implement this the Bonding arrangement were made accessible by placing them above the ground in line with the available standards & specifications as shown below. The bonding arrangement consisting of link box, bonding cables, surge voltage limiters were placed outside in a cover box specially designed for above ground applications.

Fig-11 Above the Ground Link Box

Accessible link box were provided on every joint depending on the length of the circuit.
