HV AND EHV BUSHING CONDITION ASSESSMENT – FIELD EXPERIENCE

Cigré-057

CIGRE-IEC 2016 Colloquium on EHV and UHV
Montréal, QC, Canada, May 9-11, 2016

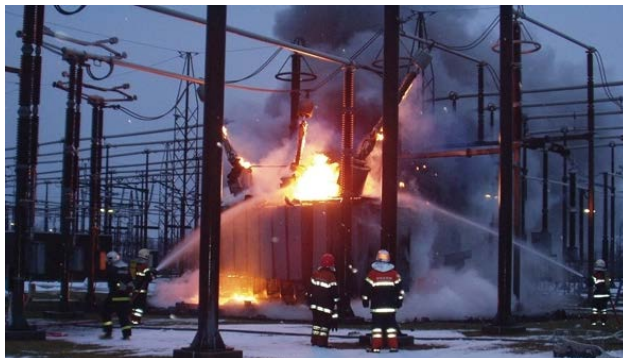
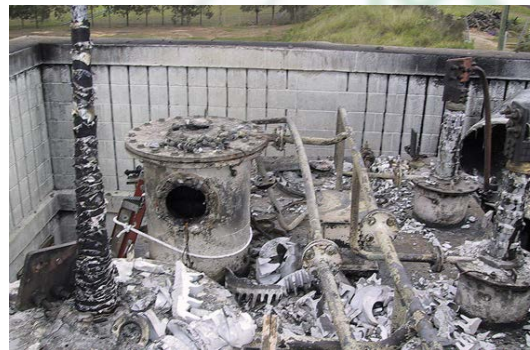
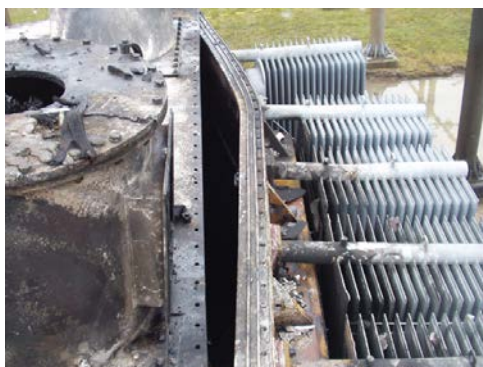
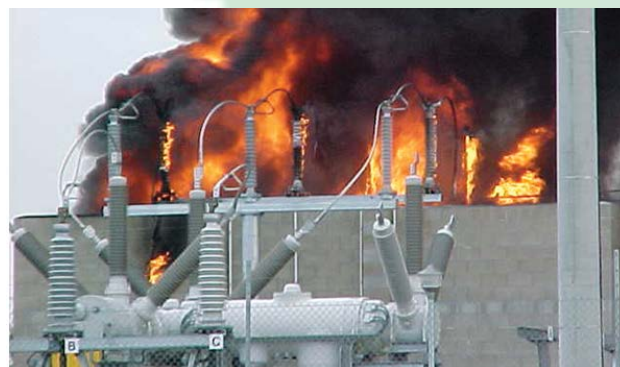
- Utility commitment for reliability and availability of HV and EHV equipment, safety of personnel and environment protection.
- CIGRE TB 642 reported 17% transformer breakdown to be caused by bushing failure followed by explosion

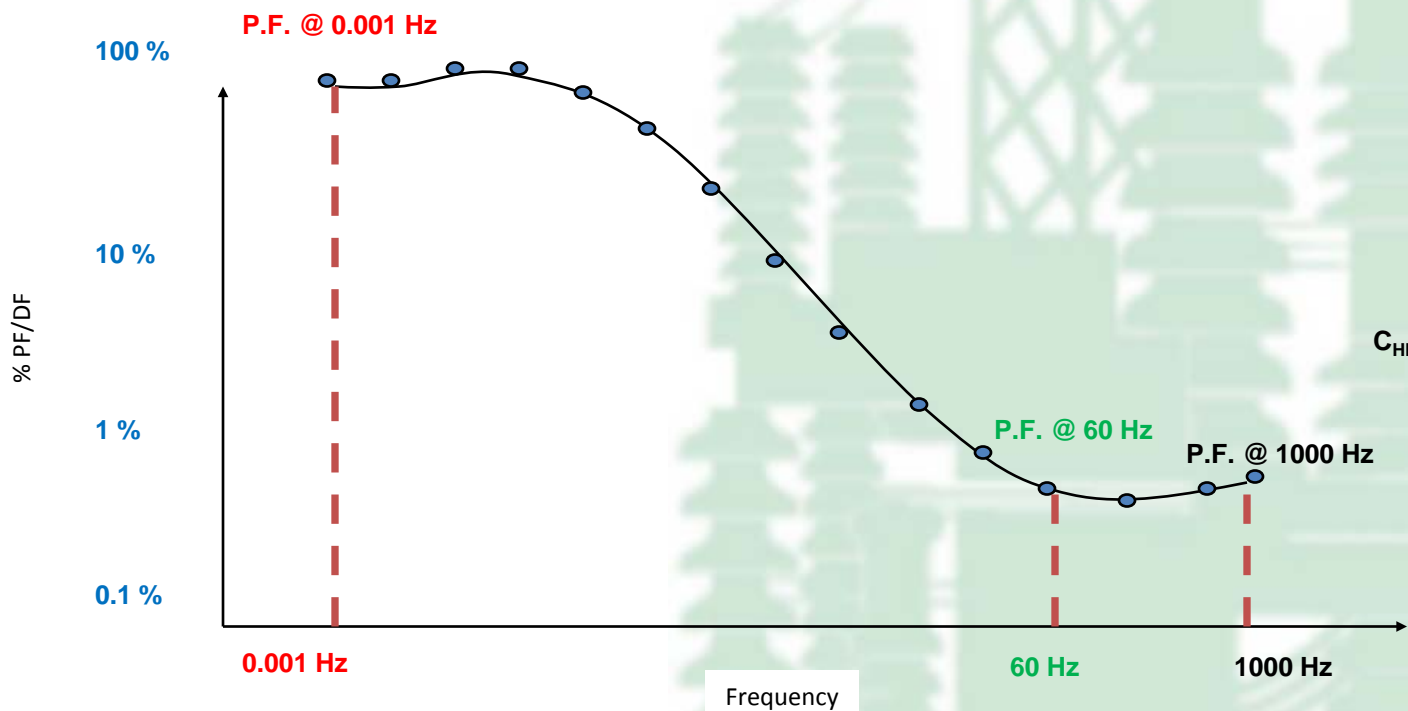
Dielectric Frequency Response (DFR) Analysis

- Measurement of capacitance, C , and power factor/dissipation factor as function of frequency, from about 1000 Hz down to 1 Hz, 0,1 Hz, 0.01 Hz or lower.
