## **Case study : effectiveness of Transformer firefighting (deluge) System in Oman Electricity Transmission Company (OETC) network**

**IBRAHIM AL BALUSHI  
OMAN ELECTRICITY TRANSMISSION COMPANY  
SULTANATE OF OMAN**

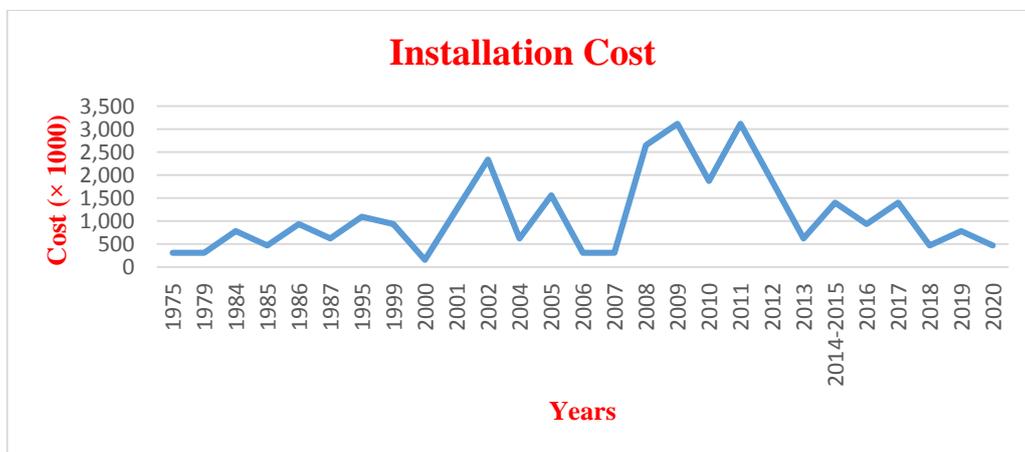
Figure 1: Installation cost of transformer firefighting system (1975-2020)

Figure 1 shows the approximate installation cost graph of transformer firefighting system within OETC during period of since 1975 to 2020. OETC is spending approximately 156,000 USD for each grid station with two transformers installed . The largest spending on the transformer firefighting system was in 2009 and 2011 with 3,120,000 USD for each year. For the next 5 years (2016-2020) there will be about 26 new grid stations to be constructed and the estimated cost for the transformer fire system is 4,056,000 USD without considering the cost of firefighting system for adding new transformers in the existing transformer is not included.

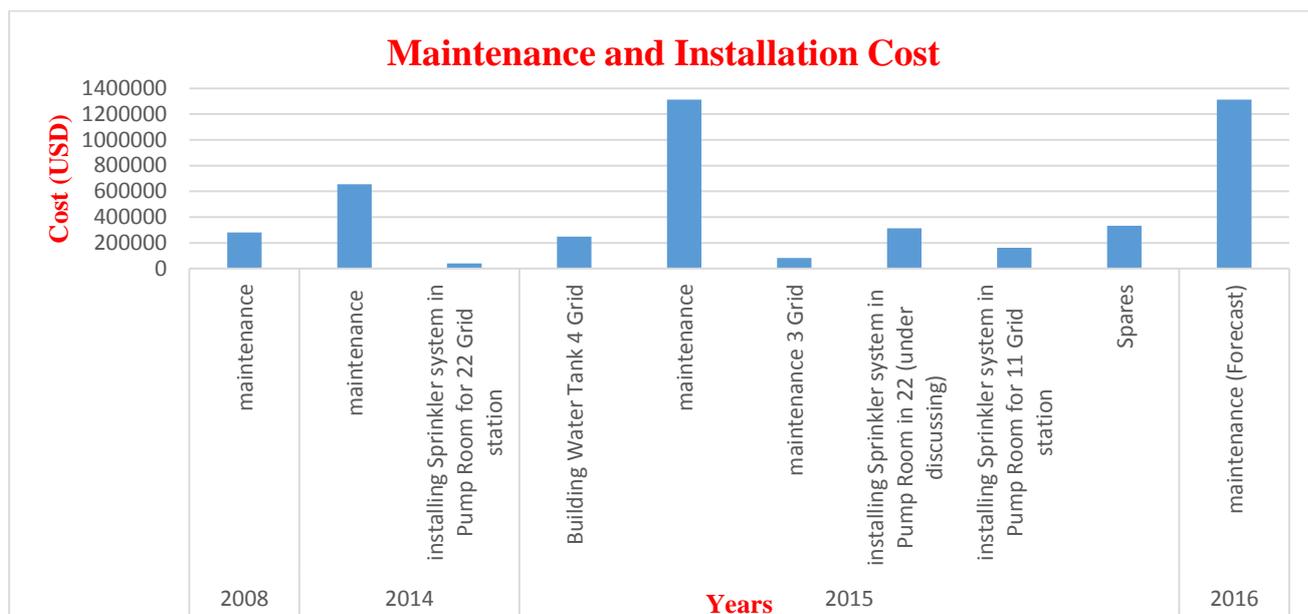
Figure 2 : Maintenance and installation cost

Figure 2 shows the approximate installation (modifications) and maintenance cost in the mentioned years. As one of the insurance’s requirements in 2013, sprinkler system must be available in each fire room and based on these requirements, approximately OETC will spend amount of 513,760 USD as shown in the figure 2 . Moreover, this requirements will be an extra cost for the future projects and cost of maintenance as well. For maintenance purpose OETC spent total amount of 2,332,399 USD in 2008, 2014 and 2015 and the estimated cost that OETC is going to spend in 2016 is 1,313,000 without considering the cost of maintaining firefighting system for the newly commissioned grid stations. However, the scope of the maintenance activity is limited to clean, inspect and check the operations, and for any replacement or spare parts, OECT shall pay that extra amount. For 2015, OETC spent approximately 333,762 USD for the spare parts which formed about 12.5% of the total OPEX of transformer firefighting system as shown in figure 2. Another cost is not included above is installing of crane in the fire pump room based on the HSE audit that was conducted in 2015.
